Manhole Inspection Summary

Manhole # S43II_037MH

Insp Date: **4/24/08 11:11 AM**

Location Address: **Rutland Ave**

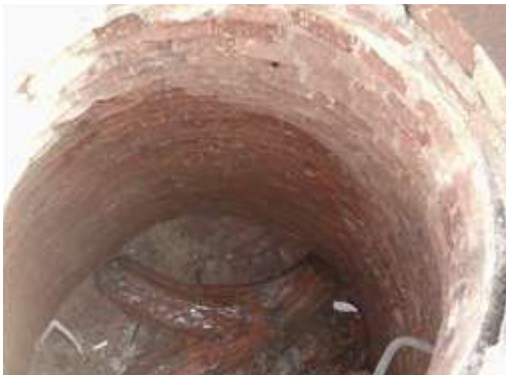
Defect 1

☒ **Leaks**

Frame Leaks

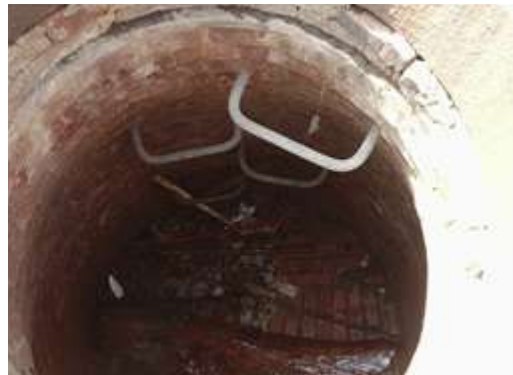
Defect 2

☒ **Loose Brick**

☒ **Deteriorated**

Loose Bricks

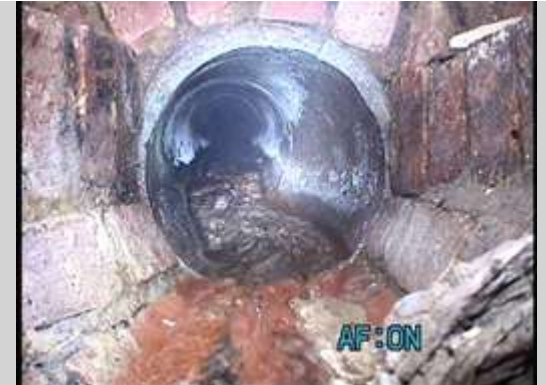
12 O'Clock Outflow

8 in. Circular Gravity Sewer
Pipe Out @ 12 O'Clock

Pipe Height: **8.4** (in.) Rod and Bar (Angled)
Pipe Material: **Clay** ☐ Pipe Lined
Invert Depth: **8.40** (ft.) Flow Characteristics: **Fast**
Deposits: ☒ None ☐ Mud ☐ Sludge ☐ Debris ☐ Grease
Silt Depth: (in.) Deposits Extent:
Infiltration: **None** Pipe Seal Cond: **Sound**

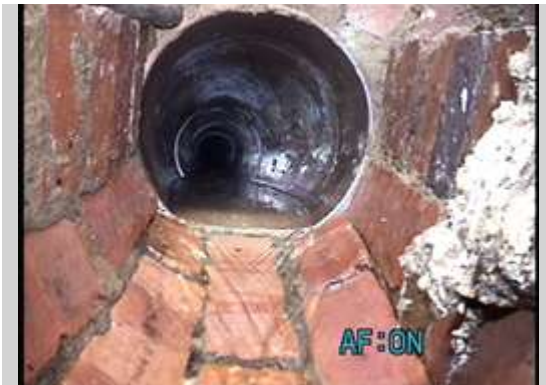
6 O'Clock Inflow

8 in. Circular Gravity Sewer
Pipe In @ 6 O'Clock

Pipe Height: **8.4** (in.) Rod and Bar (Angled)
Pipe Material: **Clay** ☐ Pipe Lined
Invert Depth: **7.80** (ft.) Flow Characteristics: **Fast**
Deposits: ☒ None ☐ Mud ☐ Sludge ☐ Debris ☐ Grease
Silt Depth: (in.) Deposits Extent:
Infiltration: **None** Pipe Seal Cond: **Sound**

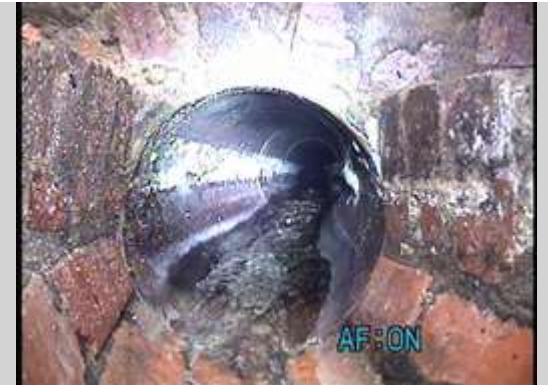
9 O'Clock Inflow

8 in. Circular Gravity Sewer

Pipe In @ 9 O'Clock

Infiltration: **None** Pipe Seal Cond: **Sound**
